**Flood Control Project Maintenance
Levee Inspections**

Fall 2019 Levee Maintenance Deficiency Summary Report

**Flood Control Project Maintenance
Levee Inspections****LMA District Cover Sheet****Fall 2019 Levee Inspection Results****Sacramento River West Side Levee District**

Sacramento River West Side Levee District

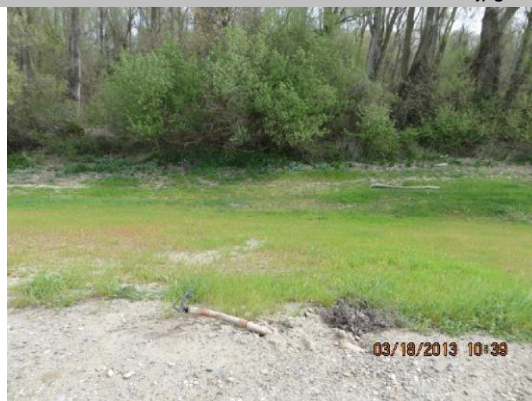
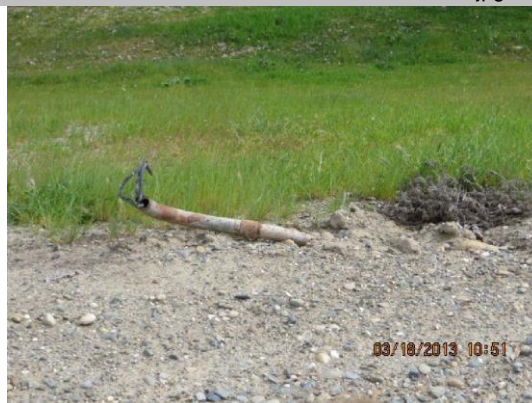
LM Start	35.56	Rating **	M	Issue No.	1639
LM End	35.56	Issue Type +	En	Location *	
Category	Supplemental			GPS Latitude/Longitude	
				Start	End
Item	DRAFT DWR UCIP Field Study			39.103533 °	39.103533 °
				-121.906814 °	-121.906814 °
DWR ID	20398				
Comment Code					
Inspector Comment					
DS_ID:20398 FS_ID:54163 EP_NO: 9364 Repair Type: Non-Urgent Crossing Status: Found UCIP Comments: 05/07/2019 Needs to be removed from the levee. (O.Yakimov - DWR UCIP)03/18/2013 Remove abandoned pipe from levee. FIELD_STRUCT_DESC: *ABANDONED* 4 of 4: 1.25-inch electrical conduit of an unknown material through the levee, 3 feet below the crown. (Automatic Board Order (ABO) issued as Permit No. 9364-A, 1974 - Alice Steidlmayer). FS Date: 5/7/2019 7:46:31 AM

Electrical conduit on WS shoulder

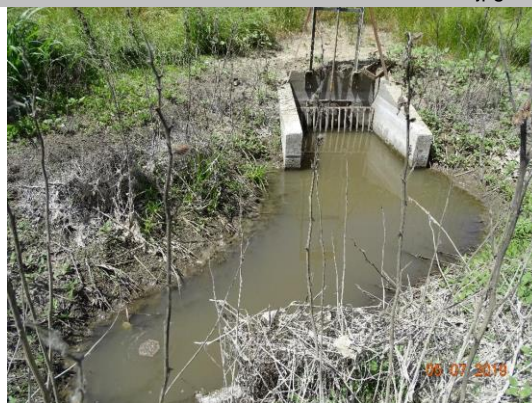
Photo 1 of 3 : UCIP_FA_2019_54164_79775.jpg

Comment Code						
Inspector Comment						
DS_ID:20345 FS_ID:54164 EP_NO: 9374 Repair Type: Non-Urgent Crossing Status: Found UCIP Comments: 05/07/2019 Pipe is capped on LS approximately 15 feet from LS toe. Minor water leakage observed around capped pipe. (O.Yakimov - DWR UCIP)03/18/2013 Verify if pipe is abandoned with landowner and remove or abandon properly if necessary. FIELD_STRUCT_DESC: *ABANDONED* 3 of 3: 24-inch concrete encased steel drainage pipe through the levee, 17 feet below the crown. Slide gate on concrete headwall on waterside (WS) end. Walkway to control gate and gate valve on landside (LS) end. (24-inch pipe [HLM 36.61] authorized under Automatic Board Order (ABO) issued as Permit No. 9374, 1974 - Richard H. Moore). [Additional Reference(s): USACE Sacramento O&M Manual 131, May 1960 (HLM 36.61)]. FS Date: 5/7/2019 8:40:51 AM

Outlet/inlet on WS toe

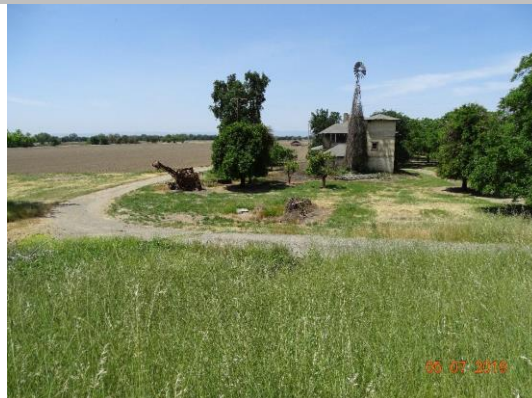
Photo 2 of 3 : UCIP_FA_2019_54164_79776.jpg

Item	DRAFT DWR UCIP LMA Responsibility			39.111233 °	39.111233 °	
				-121.911450 °	-121.911450 °	
DWR ID	20345					
Comment Code						
Inspector Comment						
DS_ID:20345 FS_ID:54164 EP_NO: 9374 Repair Type: Non-Urgent Crossing Status: Found UCIP Comments: 05/07/2019 Pipe is capped on LS approximately 15 feet from LS toe. Minor water leakage observed around capped pipe. (O.Yakimov - DWR UCIP)03/18/2013 Verify if pipe is abandoned with landowner and remove or abandon properly if necessary. FIELD_STRUCT_DESC: *ABANDONED* 3 of 3: 24-inch concrete encased steel drainage pipe through the levee, 17 feet below the crown. Slide gate on concrete headwall on waterside (WS) end. Walkway to control gate and gate valve on landside (LS) end. (24-inch pipe [HLM 36.61] authorized under Automatic Board Order (ABO) issued as Permit No. 9374, 1974 - Richard H. Moore). [Additional Reference(s): USACE Sacramento O&M Manual 131, May 1960 (HLM 36.61)]. FS Date: 5/7/2019 8:40:51 AM

LS levee slope

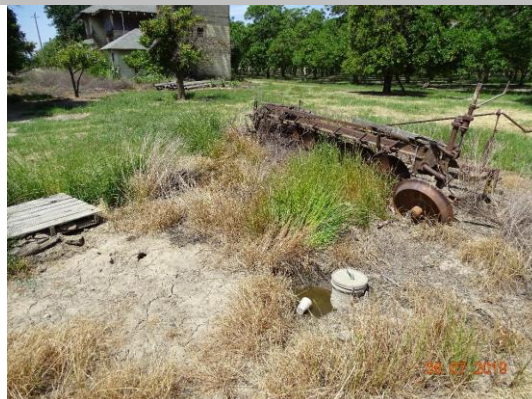
Photo 3 of 3 : UCIP_FA_2019_54164_79777.jpg

Water leaks around capped pipe on LS

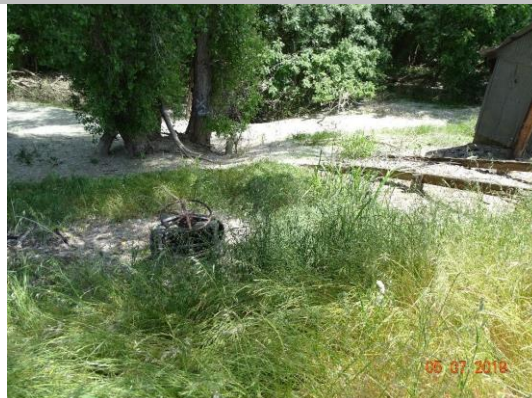
Photo 1 of 3 : UCIP_FA_2019_54166_79779.jpg

View of WS slope

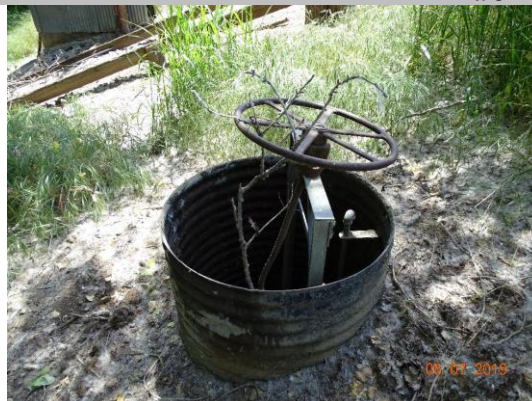
Photo 2 of 3 : UCIP_FA_2019_54166_79780.jpg

CMP riser on WS slope with inoperable slide gate

Comment Code					
Inspector Comment					
DS_ID:20274 FS_ID:54166 EP_NO: 9374 Repair Type: Non-Urgent Crossing Status: Found UCIP Comments: 05/07/2019 Slide gate in a CMP riser on WS slope is in closed position. Debris inside of CMP riser. Stem of the slide gate is bent that makes it inoperable. Pipe is cut off at WS berm and a plate bolted to the pipe end. Owner needs to abandon properly or remove pipe if not planning to use. (O.Yakimov - DWR UCIP)03/18/2013 Pipe should be abandoned properly. FIELD_STRUCT_DESC: 4 of 4: 24-inch corrugated metal irrigation pipe through the levee, 15.5 feet below the crown. Two corrugated metal cutoff walls. Slide gate in a 36-inch corrugated metal riser unit on the waterside (WS) slope. Pump house with no connection on the WS bank. 12-inch steel pipe with steel plate over end at WS toe (likely pump connection point). 6-foot diameter concrete riser on landside (LS) toe. Skid rails mounted on wood piling on the WS slope. Department of Water Resources B.M. SR 47 on top of concrete anchor post on the WS shoulder. Power pole and meter box on the WS shoulder. Switch panel in metal house on the WS slope. Concrete standpipe on the LS. Overhead power line crosses the levee to service pole. (Automatic Board Order (ABO) issued as Permit No. 9374, 1974 - Richard H. Moore). [Additional Reference(s): DWR Levee Log, 2006]. FS Date: 5/7/2019 7:51:00 AM

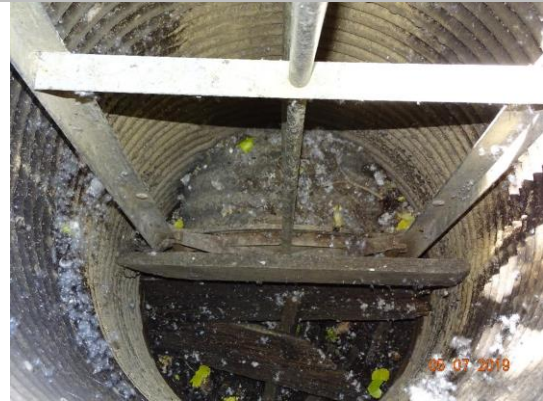
Photo 3 of 3 : UCIP_FA_2019_54166_79781.jpg

View inside of CMP riser on WS slope

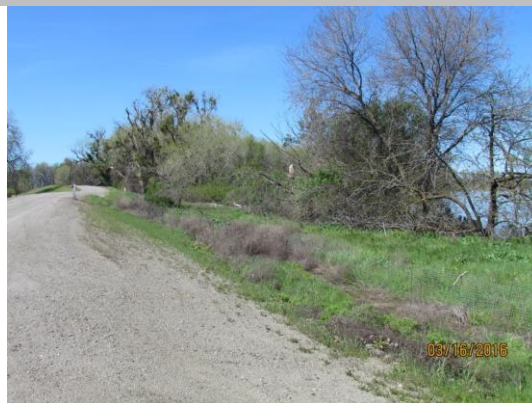
Photo 1 of 2 : FA_2019_NA0016_435_33_20190829_00013.jpg

LM Start	37.07	Rating **	A/W	Issue No.	33
LM End	37.15	Issue Type +	Ob	Location *	WS
Category	Earthen Levee			GPS Latitude/Longitude	
				Start	End
Item	Vegetation			39.121003 °	39.121547 °
				-121.919888 °	-121.921278 °
DWR ID	DWR_NA0016_01_s_2012_33				
Comment Code					
V8 : Environmental Requirements.					
Inspector Comment					
Revegetation site is fenced off.

View of the revegetation site on the waterward berm of the levee looking upstream. Spring 2016.

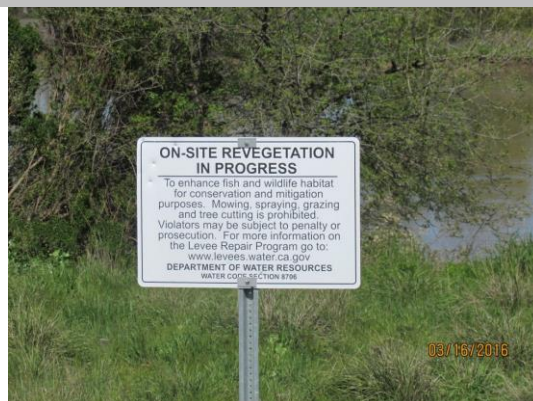
Photo 2 of 2 : FA_2019_NA0016_435_33_20190829_00014.jpg

LM Start	37.07	Rating **	A/W	Issue No.	33 (cont)	
LM End	37.15	Issue Type +	Ob	Location *	WS	
Category	Earthen Levee			GPS Latitude/Longitude		
				Start		End
Item	Vegetation			39.121003 °		39.121547 °
				-121.919888 °		-121.921278 °
DWR ID	DWR_NA0016_01_s _ 2012_33					
Comment Code						
V8 : Environmental Requirements.						
Inspector Comment						
Revegetation site is fenced off.

Sign stating the revegetation site. Spring 2016.

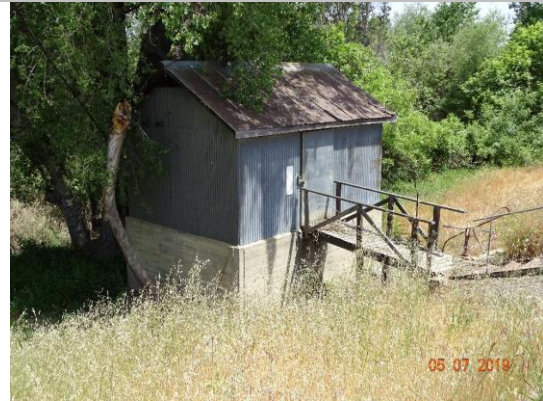
Photo 1 of 3 : UCIP_FA_2019_54173_79800.jpg

Walkway and pumphouse on LS toe

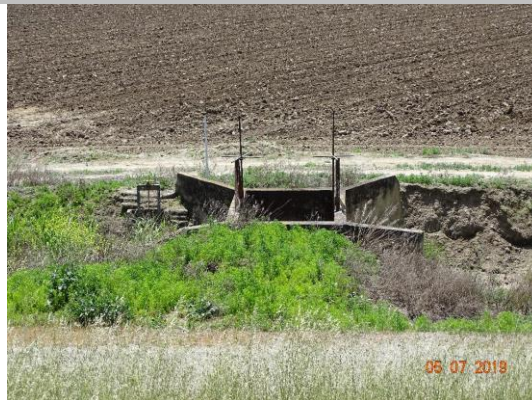
Photo 3 of 3 : UCIP_FA_2019_54173_79802.jpg

Concrete distribution box on LS toe

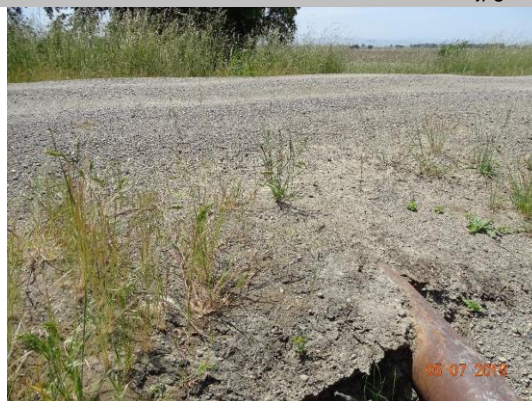
Photo 1 of 3 : UCIP_FA_2019_54061_79354.jpg

DS_ID:20307
FS_ID:54061
EP_NO: 1734
Repair Type: Urgent
Crossing Status: Found
UCIP Comments: 05/22/2019 Failed siphon breaker lets water out of pipe on WS slope that creates erosion around the pipe. Noticed multiple through holes in pipe outlet on river's edge. Owner is in process to apply for a permit to replace the pipe. (O.Yakimov - DWR UCIP)
Good candidate for video inspection as pipe is heavily rusted at outlet.
FIELD_STRUCT_DESC: 8-inch steel drainage pipe through the levee, 1 foot below the crown. One metal cutoff wall. Vertical pumping unit in drainage ditch at the landside (LS) toe. Siphon breaker on the waterside (WS) slope. (Permit No. 1734, 1953 - Davis Ranches). [Additional Reference(s): DWR Levee Log, 1980. USACE Sacramento O&M Manual 131, May 1960 (HLM 37.95)].
FS Date: 5/22/2019 8:03:31 AM

View of levee crown at crossing

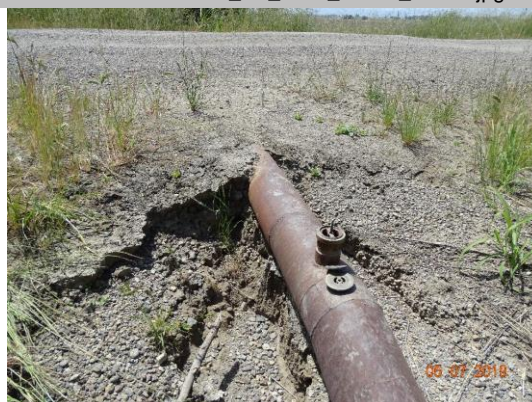
Photo 2 of 3 : UCIP_FA_2019_54061_79355.jpg

Erosion on WS slope

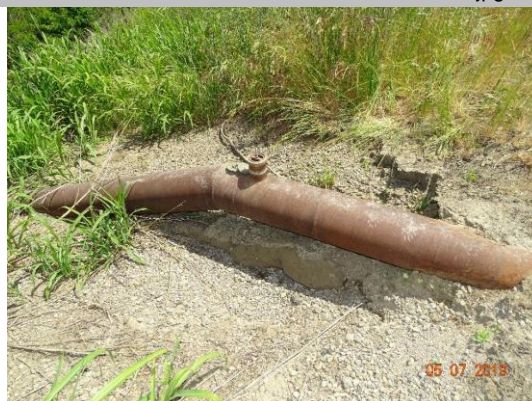
Photo 3 of 3 : UCIP_FA_2019_54061_79356.jpg

Item	DRAFT DWR UCIP Field Study			39.124064 °	39.124064 °	
				-121.926198 °	-121.926198 °	
DWR ID	20307					
Comment Code						
Inspector Comment						
DS_ID:20307 FS_ID:54061 EP_NO: 1734 Repair Type: Urgent Crossing Status: Found UCIP Comments: 05/22/2019 Failed siphon breaker lets water out of pipe on WS slope that creates erosion around the pipe. Noticed multiple through holes in pipe outlet on river's edge. Owner is in process to apply for a permit to replace the pipe. (O.Yakimov - DWR UCIP) Good candidate for video inspection as pipe is heavily rusted at outlet. FIELD_STRUCT_DESC: 8-inch steel drainage pipe through the levee, 1 foot below the crown. One metal cutoff wall. Vertical pumping unit in drainage ditch at the landside (LS) toe. Siphon breaker on the waterside (WS) slope. (Permit No. 1734, 1953 - Davis Ranches). [Additional Reference(s): DWR Levee Log, 1980. USACE Sacramento O&M Manual 131, May 1960 (HLM 37.95)]. FS Date: 5/22/2019 8:03:31 AM

Erosion on WS slope around pipe

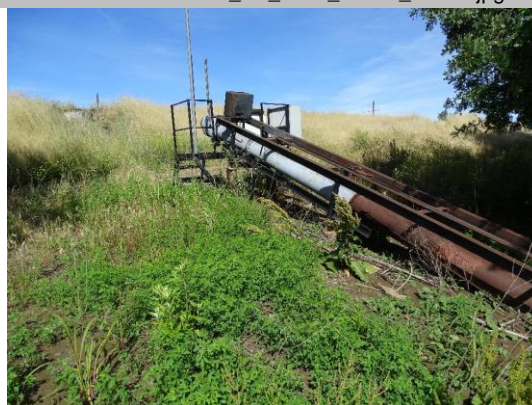
Photo 1 of 3 : UCIP_FA_2019_54177_79808.jpg

Comment Code					
Inspector Comment					
DS_ID:20277 FS_ID:54177 EP_NO: 9356 Repair Type: Non-Urgent Crossing Status: Found UCIP Comments: 05/22/2019 Cover missing on CMP riser WS. (O.Yakimov - DWR UCIP) FIELD_STRUCT_DESC: 1 of 5: 16-inch concrete encased steel irrigation pipe through the levee, 20 feet below the crown. Two concrete walls. Slant pump mounted on channel iron supports the waterside (WS) bank. Slide gate in 60-inch corrugated metal riser unit on the WS slope. Flap gate mounted in a concrete distribution box on the landside (LS). Water meter in 48-inch corrugated metal riser unit on the WS berm. (Automatic Board Order (ABO) issued as Permit No. 9356, 1974 - Annie D. Propfe). (Pipe installed by the United States Army Corps of Engineers, 1962). [Additional Reference(s): DWR Levee Log, 2006]. FS Date: 5/22/2019 1:06:22 PM

Pumping platform on WS berm

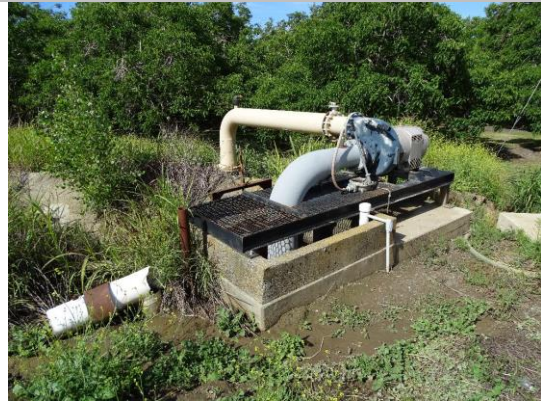
Photo 2 of 3 : UCIP_FA_2019_54177_79809.jpg

Pump at LS concrete distribution box

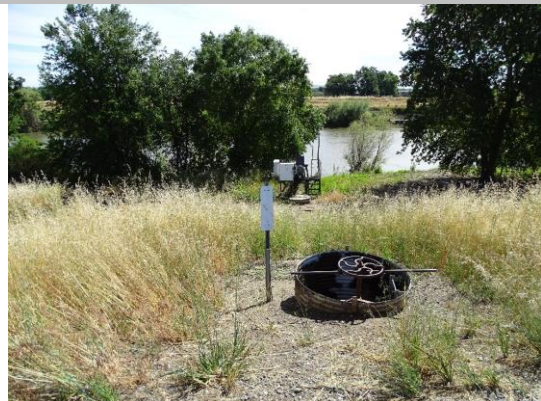
Photo 3 of 3 : UCIP_FA_2019_54177_79810.jpg

Item	DRAFT DWR UCIP Field Study			39.132576°	39.132576°	
				-121.938774°	-121.938774°	
DWR ID	20277					
Comment Code						
Inspector Comment						
DS_ID:20277 FS_ID:54177 EP_NO: 9356 Repair Type: Non-Urgent Crossing Status: Found UCIP Comments: 05/22/2019 Cover missing on CMP riser WS. (O.Yakimov - DWR UCIP) FIELD_STRUCT_DESC: 1 of 5: 16-inch concrete encased steel irrigation pipe through the levee, 20 feet below the crown. Two concrete walls. Slant pump mounted on channel iron supports the waterside (WS) bank. Slide gate in 60-inch corrugated metal riser unit on the WS slope. Flap gate mounted in a concrete distribution box on the landside (LS). Water meter in 48-inch corrugated metal riser unit on the WS berm. (Automatic Board Order (ABO) issued as Permit No. 9356, 1974 - Annie D. Propfe). (Pipe installed by the United States Army Corps of Engineers, 1962). [Additional Reference(s): DWR Levee Log, 2006]. FS Date: 5/22/2019 1:06:22 PM

WS slope and CMP riser on the slope

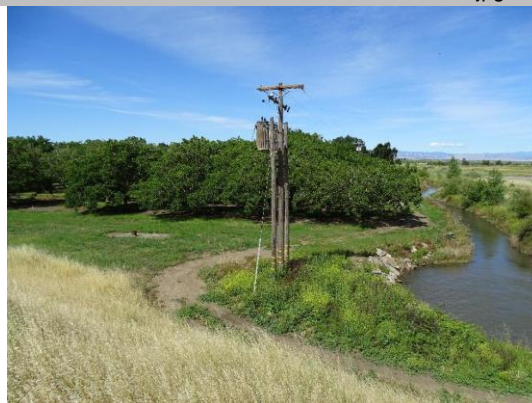
Photo 1 of 3 : UCIP_FA_2019_54192_79829.jpg

Power pole on LS

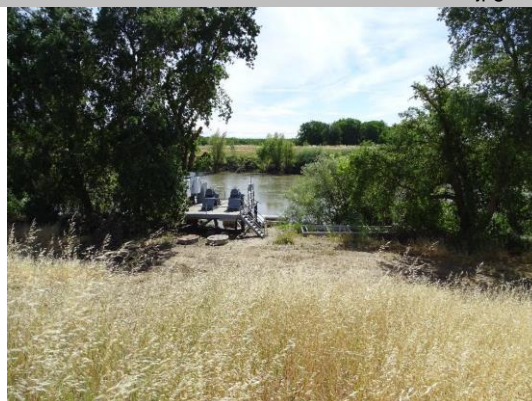
Photo 2 of 3 : UCIP_FA_2019_54192_79830.jpg

Pumping platform of WS berm

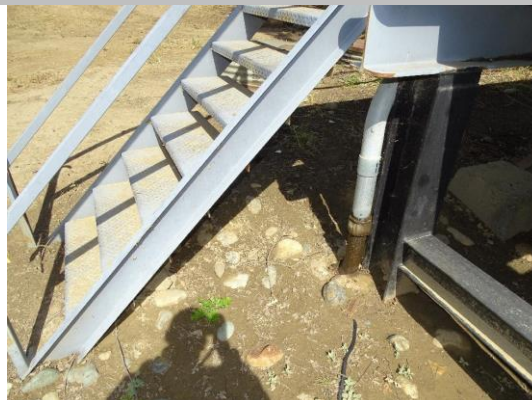
Photo 3 of 3 : UCIP_FA_2019_54192_79831.jpg

Conduit comes out of the ground near pumping platform

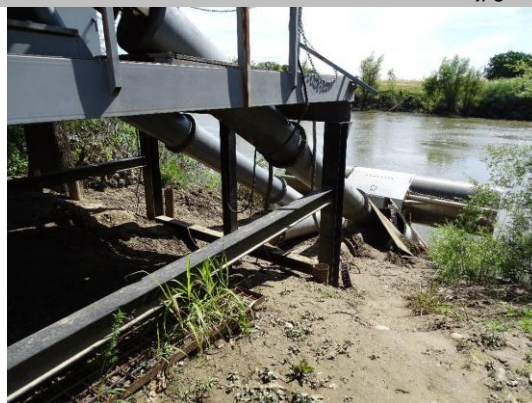
Photo 1 of 3 : UCIP_FA_2019_54194_79835.jpg

Pumping platform and pipe at WS berm

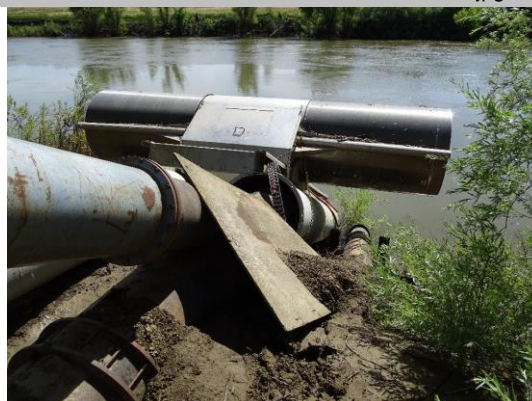
Photo 2 of 3 : UCIP_FA_2019_54194_79836.jpg

Pipe and fish screen at riverbank

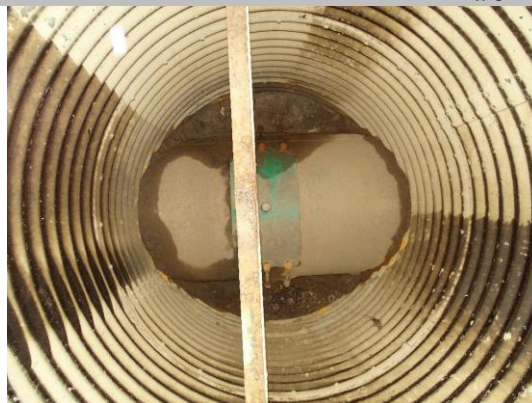
Photo 3 of 3 : UCIP_FA_2019_54194_79832.jpg

View inside of CMP riser next to pumping platform

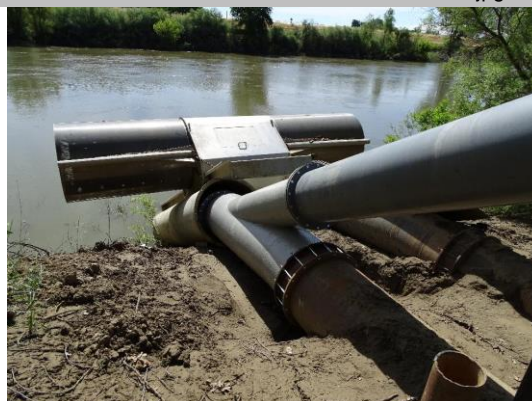
Photo 1 of 3 : UCIP_FA_2019_54195_79838.jpg

Pipe and fish screen at riverbank

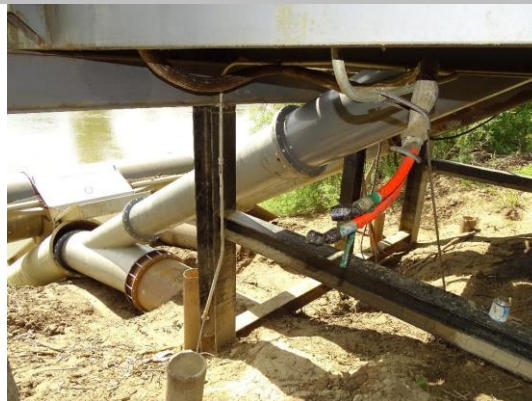
Photo 2 of 3 : UCIP_FA_2019_54195_79842.jpg

Pumping platform and pipe at WS berm

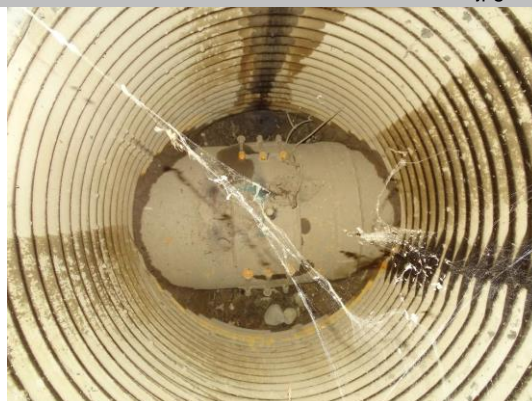
Photo 3 of 3 : UCIP_FA_2019_54195_79841.jpg

View inside of CMP riser next to pumping platform

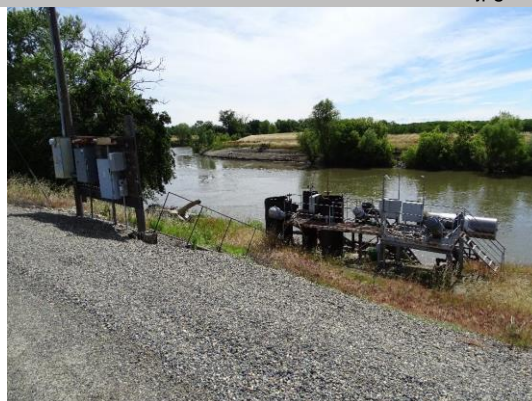
Photo 1 of 3 : UCIP_FA_2019_54197_79845.jpg

Pumping platform at WS toe

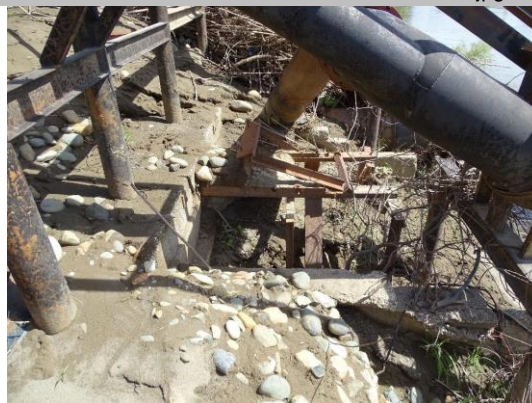
Photo 2 of 3 : UCIP_FA_2019_54197_79843.jpg

3'X6' concrete irrigation tunnel through the levee. Pipe is sealed at its entrance

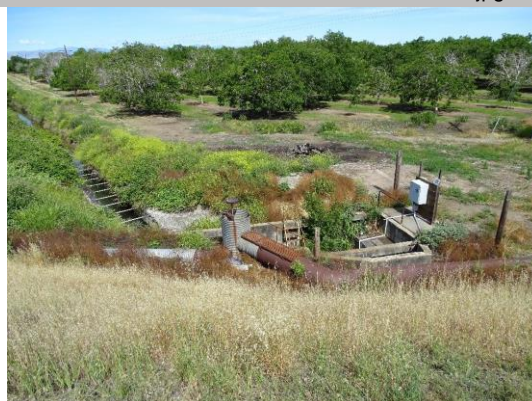
Photo 3 of 3 : UCIP_FA_2019_54197_79846.jpg

LS slope with crossing appurtenances

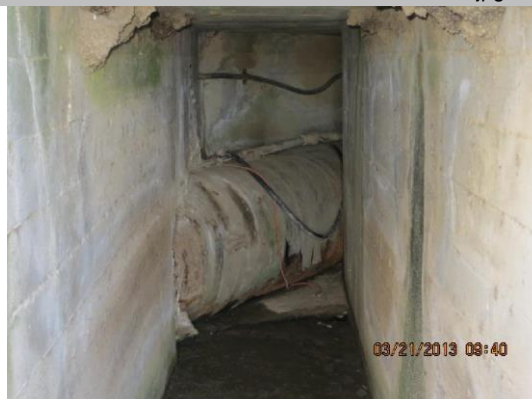
Photo 1 of 3 : UCIP_FA_2019_54201_17802.jpg

LM Start	39.18	Rating **	M	Issue No.	1657
LM End	39.18	Issue Type +	En	Location *	
Category	Supplemental			GPS Latitude/Longitude	
				Start	End
Item	DRAFT DWR UCIP Field Study			39.143262 °	39.143262 °
				-121.939668 °	-121.939668 °
DWR ID	20418				
Comment Code					
Inspector Comment					
DS_ID:20418					
FS_ID:54201					
EP_NO: N/A					
Repair Type: Non-Urgent					
Crossing Status: Found					
UCIP Comments: 05/22/18 Permit not available (O.Yakimov - DWR UCIP)					
FIELD_STRUCT_DESC: 2 of 2: 3-foot by 6-foot reinforced concrete box irrigation tunnel through the levee, 27.5 feet below the crown. Pipe runs through concrete tunnel. Tunnel installed in 1916. (Mentioned in Permit No. 3278, 1960 - Olive Percy Davis). [Additional Reference(s): DWR Levee Log, 2006].					
FS Date: 5/22/2019 2:08:00 PM

Pipe running through 3'X6' concrete tunnel at LS.

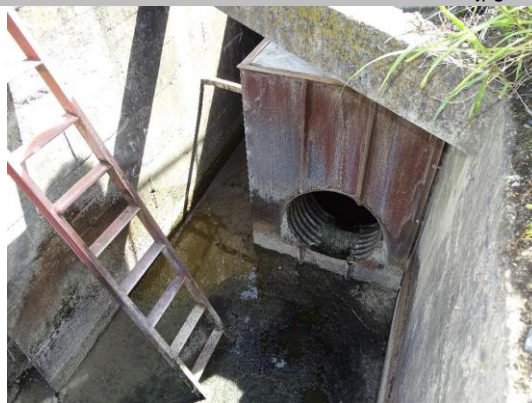
Photo 3 of 3 : UCIP_FA_2019_54201_79865.jpg

Concrete tunnel opens in concrete structure on LS

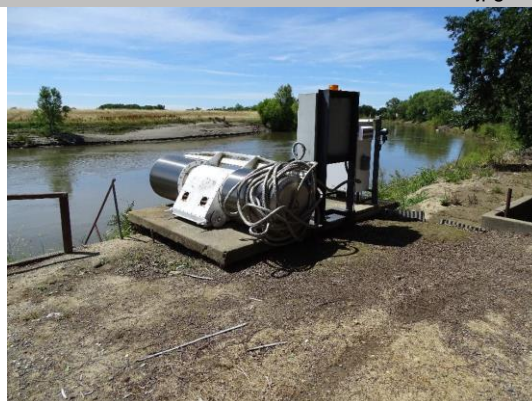
Photo 1 of 3 : UCIP_FA_2019_54203_79868.jpg

LM Start	39.33	Rating **	M	Issue No.	1658	
LM End	39.33	Issue Type +	En	Location *		
Category	Supplemental			GPS Latitude/Longitude		
				Start	End	
Item	DRAFT DWR UCIP Field Study			39.144834 °	39.144834 °	
				-121.937892 °	-121.937892 °	
DWR ID	22965					
Comment Code						
Inspector Comment						
DS_ID:22965						
FS_ID:54203						
EP_NO: 9341						
Repair Type: Non-Urgent						
Crossing Status: Found						
UCIP Comments: 05/22/2019 No issues recorded during inspection (O.Yakimov - DWR UCIP)						
FIELD_STRUCT_DESC: 2-inch electrical conduit of an unknown material through the levee, at an unknown depth. Provides power for pump on waterside (WS) berm.						
FS Date: 5/22/2019 2:45:10 PM

Pump on WS berm

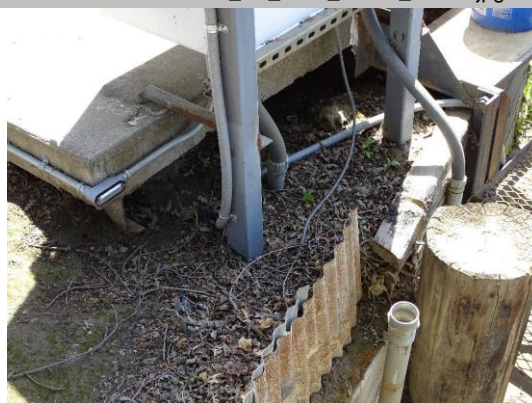
Photo 2 of 3 : UCIP_FA_2019_54203_79869.jpg

Conduit coming out of ground at pumping platform

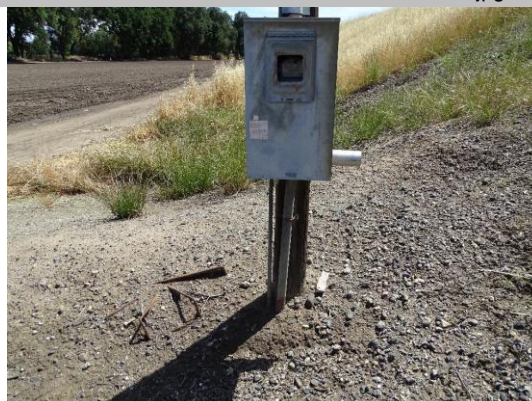
Photo 3 of 3 : UCIP_FA_2019_54203_79870.jpg

Electical panel and conduit at service pole

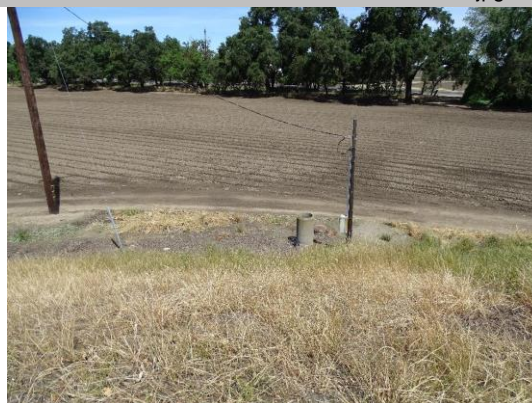
Photo 1 of 3 : UCIP_FA_2019_54204_79873.jpg

Comment Code						
Inspector Comment						
DS_ID:20280 FS_ID:54204 EP_NO: 9341 Repair Type: Non-Urgent Crossing Status: Found UCIP Comments: 05/22/2019 Pipe between pump and riverbank was replaced. (O.Yakimov - DWR UCIP) FIELD_STRUCT_DESC: 24-inch reinforced concrete irrigation pipe through the levee, 21 feet below the crown. Slide gate on the waterside (WS) end in a concrete surge box with flap gates. Pump platform on the WS berm. Pipe discharges into a concrete riser at the toe of the landside (LS) slope. (Automatic Board Order (ABO) issued as Permit No. 9341, 1974 - F. J. Steidlmayer). [Additional Reference(s): DWR Levee Log, 2006. USACE Sacramento O&M Manual 131, May 1960 (HLM 39.82)]. FS Date: 5/22/2019 2:46:43 PM

LS slope at crossing. Concrete standpipe at LS toe

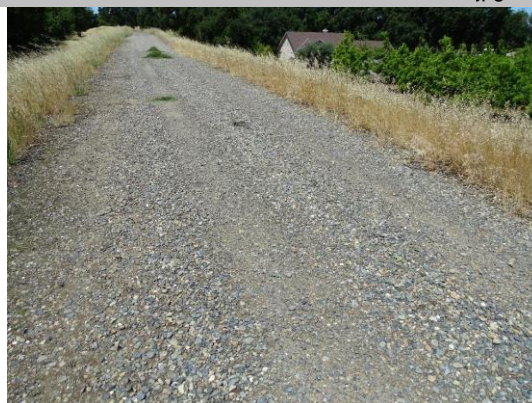
Photo 1 of 3 : UCIP_FA_2019_54207_79878.jpg

Comment Code						
Inspector Comment						
DS_ID:20282 FS_ID:54207 EP_NO: 635 Repair Type: Non-Urgent Crossing Status: Found UCIP Comments: 05/22/2019 Water is high, no pipe visible at riverbank. (O.Yakimov - DWR UCIP)03/21/2013 Pipe appears to have been removed from levee section. Need to verify pipe abandonment. FIELD_STRUCT_DESC: 12-inch steel irrigation pipe through the levee, 5 feet below the crown. Switch house on the waterside (WS) shoulder. Pump and gate valve on the WS bank. Concrete discharge standpipe on the landside (LS). (For a 14-inch pipe, Permit No. 635, 1935 - Henry F. Schmidt). (Automatic Board Order (ABO) issued as Permit No. 9351, 1974 - W. A. Gerrans). [Additional Reference(s): DWR Levee Log, 2006. USACE Sacramento O&M Manual 131, May 1960 (HLM 40.43)]. FS Date: 5/22/2019 8:16:21 AM

Levee crown at crossing

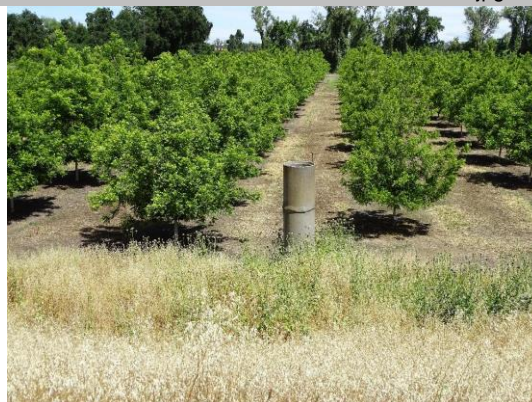
Photo 2 of 3 : UCIP_FA_2019_54207_79879.jpg

Concrete standpipe at LS toe

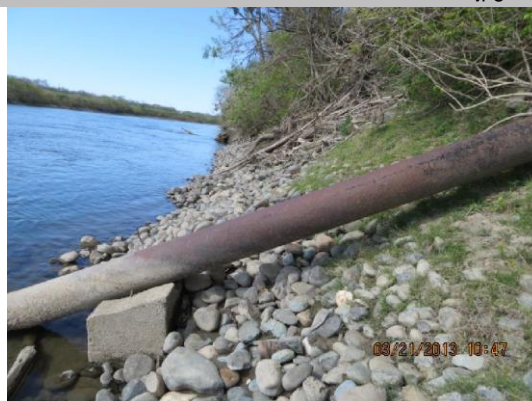
Photo 3 of 3 : UCIP_FA_2019_54207_17853.jpg

Pipe visible at WS toe.

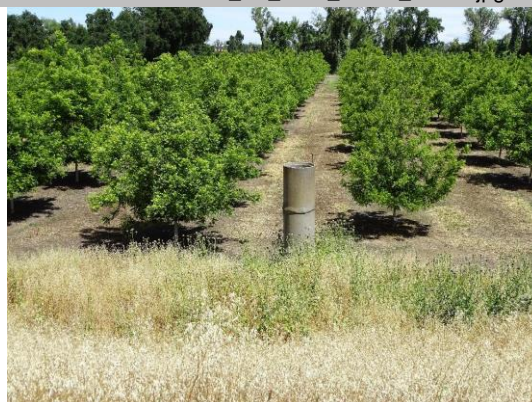
Photo 1 of 2 : UCIP_FA_2019_54208_79881.jpg

LM Start	39.93	Rating **	M	Issue No.	1662
LM End	39.93	Issue Type +	En	Location *	
Category	Supplemental			GPS Latitude/Longitude	
				Start	End
Item	DRAFT DWR UCIP Field Study			39.143387 °	39.143387 °
				-121.927196 °	-121.927196 °
DWR ID	22966				
Comment Code					
Inspector Comment					
DS_ID:22966 FS_ID:54208 EP_NO: 9352 Repair Type: Non-Urgent Crossing Status: Found UCIP Comments: 05/22/2019 Conduit is visible in LS slope. (O.Yakimov - DWR UCIP)03/21/2013 Pipe should be removed. FIELD_STRUCT_DESC: 1.5-inch galvanized steel electrical conduit through the levee, at an unknown depth. Visible on the waterside (WS) slope. (Permit No. 635, 1935 - Henry F. Schmidt). FS Date: 5/22/2019 8:25:07 AM

Electrical conduit approximately perpendicular to concrete riser on LS toe

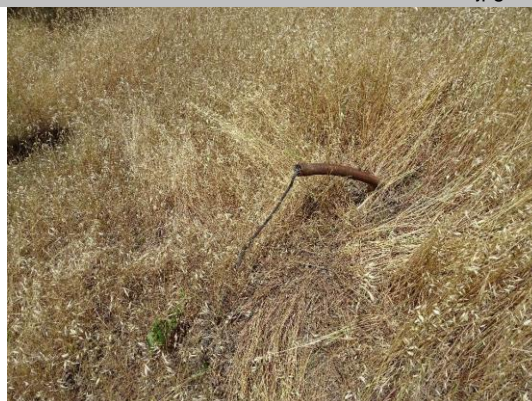
Photo 2 of 2 : UCIP_FA_2019_54208_79882.jpg

Electical conduit on WS slope

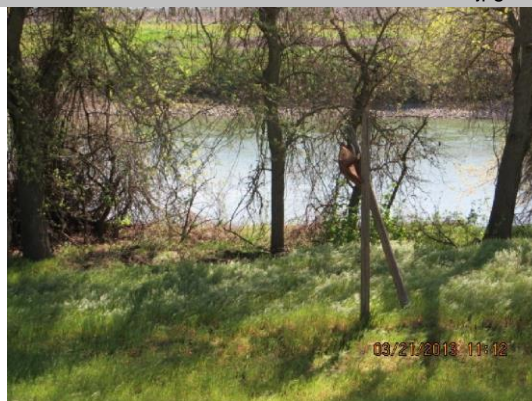
Photo 1 of 1 : UCIP_FA_2019_54209_17855.jpg

LM Start	40.36	Rating **	M	Issue No.	1663
LM End	40.36	Issue Type +	En	Location *	
Category	Supplemental			GPS Latitude/Longitude	
				Start	End
Item	DRAFT DWR UCIP Field Study			39.142602 °	39.142602 °
				-121.919804 °	-121.919804 °
DWR ID	20283				
Comment Code					
Inspector Comment					
DS_ID:20283					
FS_ID:54209					
EP_NO: 1508					
Repair Type: Non-Urgent					
Crossing Status: Indicator Found					
UCIP Comments: 05/22/2019 Unable to locate a sign on WS berm.					
Crossing alignment needs markers. (O.Yakimov - DWR UCIP)					
FIELD_STRUCT_DESC: 4-inch telephone cable of an unknown					
material through the levee, 4 feet below the crown. Old rusty sign at					
waterside (WS) toe of levee. (Permit No. 1508, 1950 - PT&T).					
[Additional Reference(s): DWR Levee Log, 2006].					
FS Date: 5/22/2019 8:41:06 AM

rusty sign on WS toe.

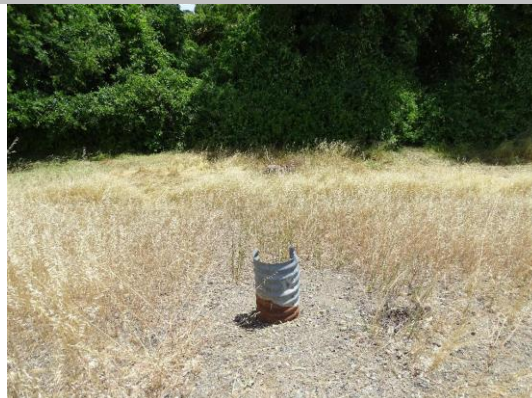
Photo 1 of 3 : UCIP_FA_2019_54212_79888.jpg

Comment Code						
Inspector Comment						
DS_ID:20285 FS_ID:54212 EP_NO: 12799 Repair Type: Non-Urgent Crossing Status: Found UCIP Comments: 05/22/2019 Pipe is capped at WS toe. If pipe is abandoned then should be done properly. (O.Yakimov - DWR UCIP)03/21/2013 Pipe appears abandoned. Need to verify type of abandonment FIELD_STRUCT_DESC: 18-inch steel irrigation pipe through the levee, 6.5 feet below the crown. 30-inch corrugated metal standpipe on landside (LS) toe. Pump on the waterside (WS) toe. Vent inside a 12-inch corrugated metal riser unit on the WS shoulder. (Permit No. 12799, 1979 - Bruce Myers). [Additional Reference(s): DWR Levee Log, 2006]. FS Date: 5/22/2019 10:13:13 AM

12-inch CMP riser on WS shoulder

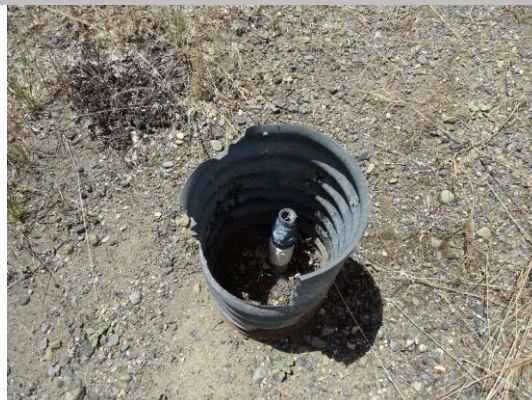
Photo 2 of 3 : UCIP_FA_2019_54212_79891.jpg

Air vent in CMP riser on WS shoulder

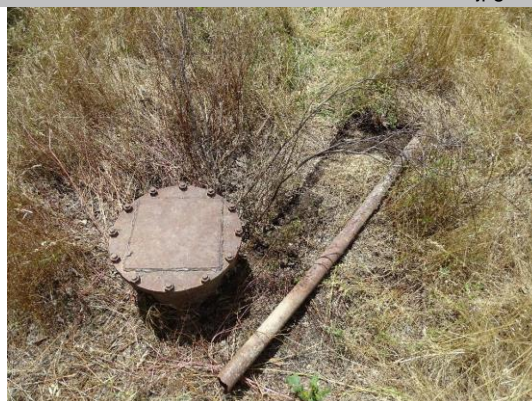
Photo 3 of 3 : UCIP_FA_2019_54212_79889.jpg

Bolted cap over pipe at WS toe

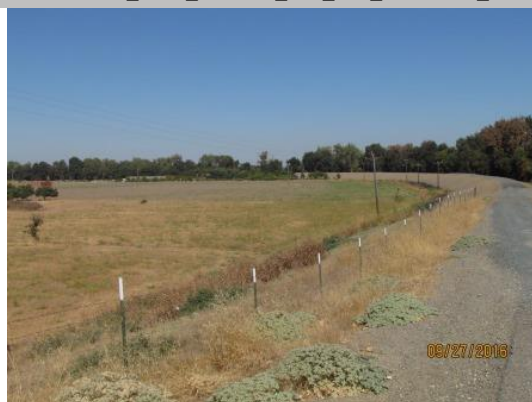
Photo 1 of 1 : FA_2019_NA0016_435_102_20190829_00038.jpg

LM Start	40.64	Rating **	M	Issue No.	102
LM End	40.72	Issue Type +	En	Location *	LS
Category	Earthen Levee			GPS Latitude/Longitude	
				Start	End
Item	Encroachments			39.146602 °	39.147582 °
				-121.918897 °	-121.918429 °
DWR ID	DWR_NA0016_01_s_2015_102				
Comment Code					
FE : Fence					
Inspector Comment

View of owner's fence on landside. Fall 2016 inspection.

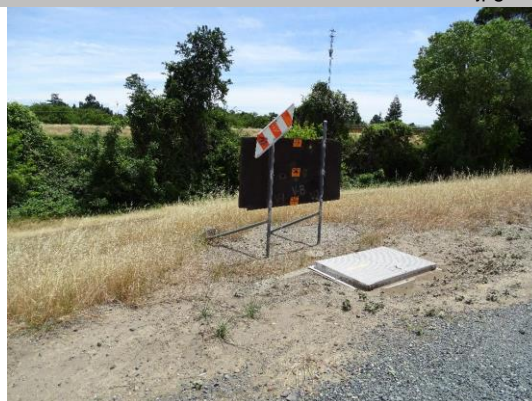
Photo 1 of 3 : UCIP_FA_2019_54213_79892.jpg

LM Start	40.69	Rating **	M	Issue No.	1665	
LM End	40.69	Issue Type +	En	Location *		
Category	Supplemental			GPS Latitude/Longitude		
				Start	End	
Item	DRAFT DWR UCIP Field Study			39.147151°	39.147151°	
				-121.918456°	-121.918456°	
DWR ID	20318					
Comment Code						
Inspector Comment						
DS_ID:20318						
FS_ID:54213						
EP_NO: N/A						
Repair Type: Non-Urgent						
Crossing Status: Indicator Found						
UCIP Comments: 05/22/2019 Crossing has a missing permit.						
(O.Yakimov - DWR UCIP)						
FIELD_STRUCT_DESC: 3-inch steel gas pipeline through the levee,						
4.0 feet below the crown. Concrete vault and sign on the waterside						
(WS) shoulder.						
FS Date: 5/22/2019 11:01:31 AM

Gasline markers and concrete vault on WS shoulder

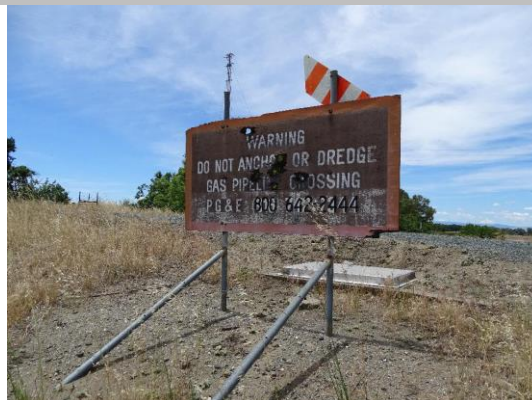
Photo 2 of 3 : UCIP_FA_2019_54213_79893.jpg

Gasline sign on WS slope

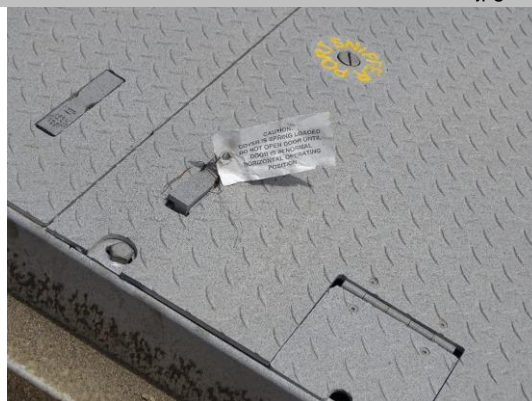
Photo 3 of 3 : UCIP_FA_2019_54213_79894.jpg

Warning tag on vault cover

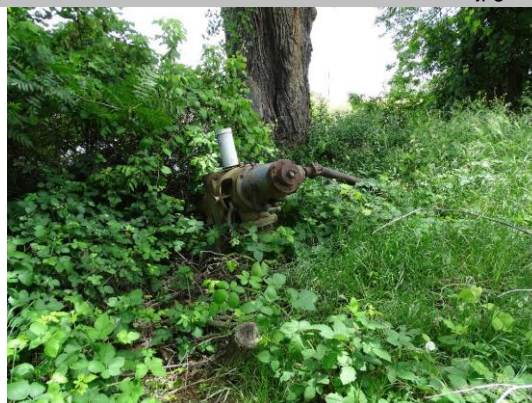
Photo 1 of 3 : UCIP_FA_2019_54215_79900.jpg

Comment Code						
Inspector Comment						
DS_ID:20287 FS_ID:54215 EP_NO: 9351 Repair Type: Non-Urgent Crossing Status: Found UCIP Comments: 05/22/2019 Damaged C-shaped concrete headwall at LS toe. Crossing looks abandoned. If not in use then should be abandoned properly. (O.Yakimov - DWR UCIP)03/21/2013 Appears abandoned. Should be abandoned properly. FIELD_STRUCT_DESC: 30-inch corrugated metal irrigation pipe through the levee, 17.5 feet below the crown. Slide gate on the waterside (WS) end. Discharges into a concrete box at the landside (LS) toe. Small pump discharges into a sump area in front of slide gate at WS toe. (Automatic Board Order (ABO) issued as Permit No. 9351, 1974 - W. A. Gerrans). [Additional Reference(s): DWR Levee Log, 2006. USACE Sacramento O&M Manual 131, May 1960 (HLM 41.39)]. FS Date: 5/22/2019 11:38:11 AM

Abandoned small pump on WS berm

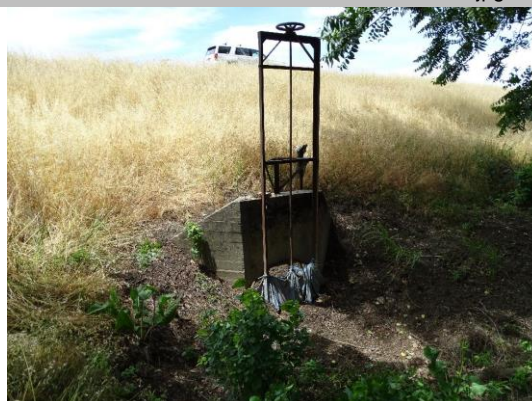
Photo 2 of 3 : UCIP_FA_2019_54215_79899.jpg

Slide gate at WS toe

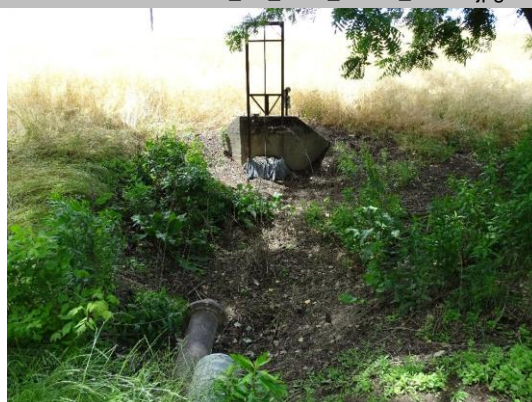
Photo 3 of 3 : UCIP_FA_2019_54215_79901.jpg

Slide gate at WS toe and sump area in front of slide gate

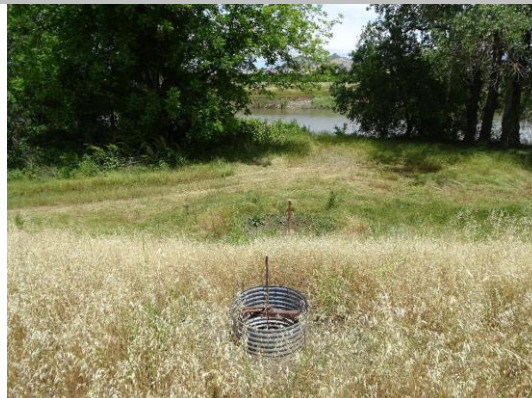
Photo 1 of 3 : UCIP_FA_2019_54216_79906.jpg

Comment Code						
Inspector Comment						
DS_ID:20288 FS_ID:54216 EP_NO: N/A Repair Type: Non-Urgent Crossing Status: Found UCIP Comments: 05/22/2019 CMP riser on WS shoulder missing a cover that creates fall hazard. A new electrical conduit is noticed on WS berm near pipe alignment. (O.Yakimov - DWR UCIP) FIELD_STRUCT_DESC: 24-inch drainage pipe of an unknown material through the levee, 19 feet below the crown. 6-foot diameter corrugated metal standpipe on the landside (LS) toe. Pump and 24-inch pipe on the LS. Slide gate in corrugated metal riser unit on waterside (WS) slope. Concrete block wall at WS toe for discharge line. (Modified under Permit No. 8587, 1973 - Anthony E. Steidlmayer). [Additional Reference(s): DWR Levee Log, 2006. USACE Sacramento O&M Manual 131, May 1960 (HLM 41.56)]. FS Date: 5/22/2019 2:35:19 PM

Corrugated metal riser on WS shoulder

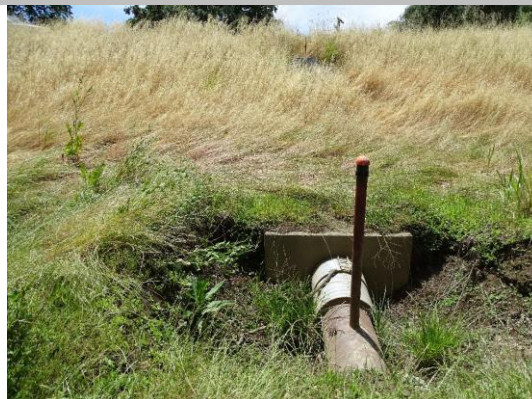
Photo 2 of 3 : UCIP_FA_2019_54216_79904.jpg

Concrete block wall at WS toe

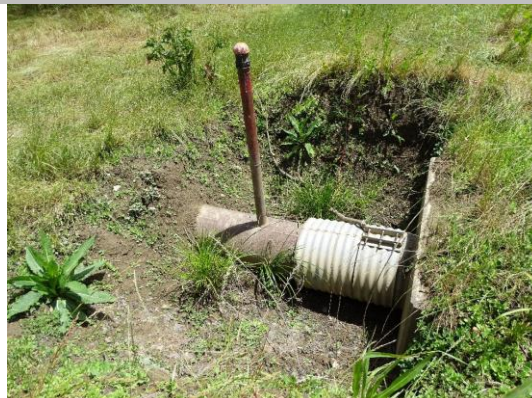
Photo 3 of 3 : UCIP_FA_2019_54216_79903.jpg

Siphon breaker on pipe at WS toe

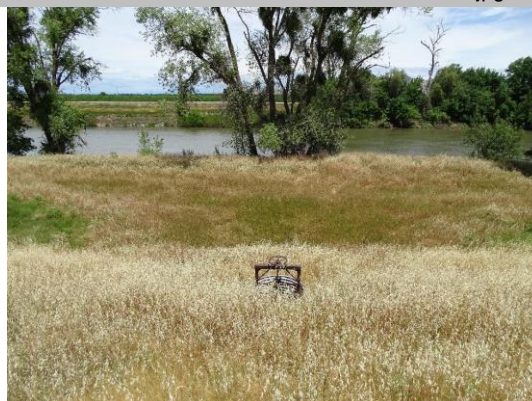
Photo 1 of 3 : UCIP_FA_2019_54217_79908.jpg

Comment Code						
Inspector Comment						
DS_ID:20289 FS_ID:54217 EP_NO: 9341 Repair Type: Non-Urgent Crossing Status: Found UCIP Comments: 05/22/2019 Uncovered CMP riser on WS shoulder is too low. Potential fall hazard. Slide gate in CMP riser buried in soil and not operable. (O.Yakimov - DWR UCIP)03/21/2013 Appears abandoned. Needs to be abandoned properly. FIELD_STRUCT_DESC: 30-inch irrigation pipe of an unknown material through the levee, 19.5 feet below the crown. Slide gate in a 36-inch corrugated metal riser unit on the waterside (WS) slope. (Automatic Board Order (ABO) issued as Permit No. 9341, 1974 - F. J. Steidlmayer). [Additional Reference(s): DWR Levee Log, 2006. USACE Sacramento O&M Manual 131, May 1960 (HLM 42.37)]. FS Date: 5/22/2019 3:32:10 PM

WS slope with 36-inch CMP riser

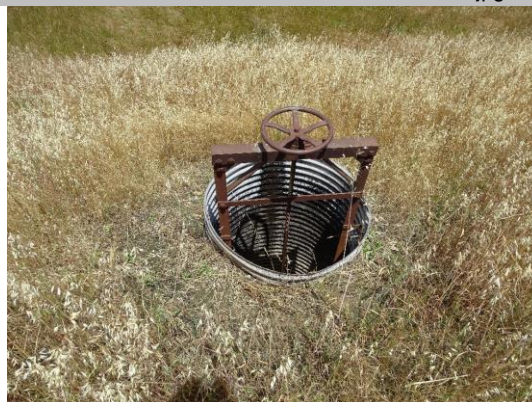
Photo 2 of 3 : UCIP_FA_2019_54217_79909.jpg

Missing cover of CMP riser

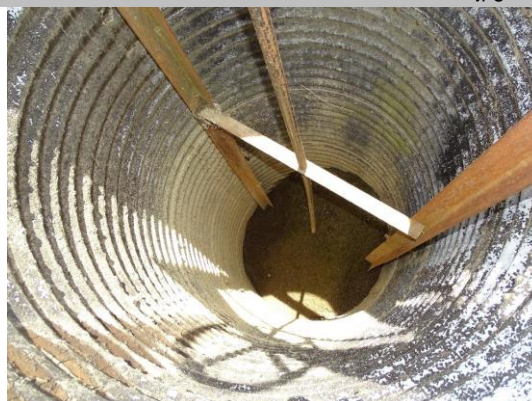
Photo 3 of 3 : UCIP_FA_2019_54217_79910.jpg

Inside view of CMP riser WS slope. Slide gate is covered with soil

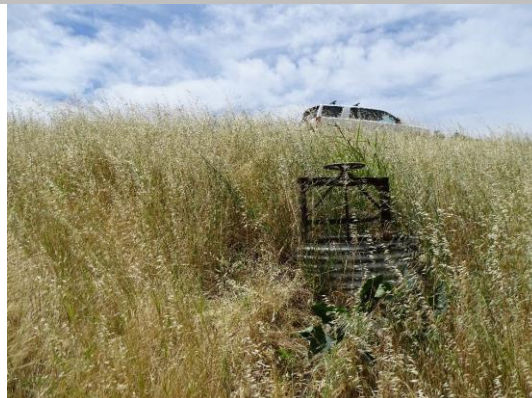
Photo 1 of 3 : UCIP_FA_2019_54218_79914.jpg

CMP riser on WS slope

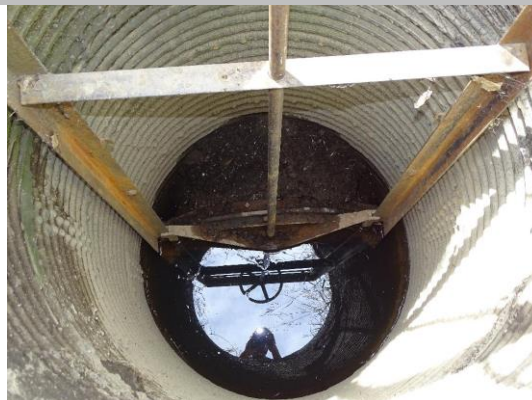
Photo 2 of 3 : UCIP_FA_2019_54218_79913.jpg

Inside view of CMP riser on WS slope

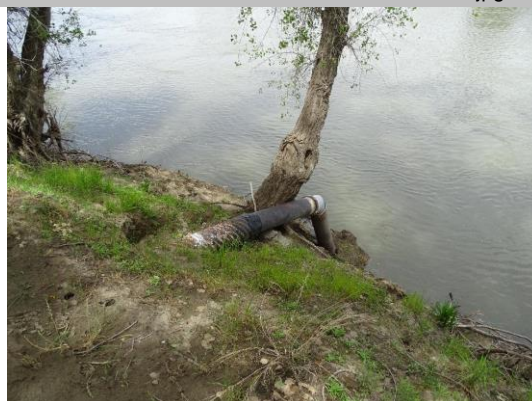
Photo 3 of 3 : UCIP_FA_2019_54218_79915.jpg

Pipe at river's edge

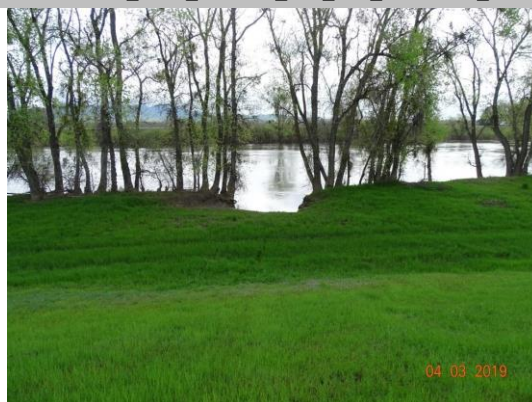
Photo 1 of 1 : FA_2019_NA0016_435_119_20190829_00053.jpg

LM Start	42.47	Rating **	A/W	Issue No.	119
LM End	42.47	Issue Type +	Ma	Location *	WS
Category	Earthen Levee			GPS Latitude/Longitude	
				Start	End
Item	Erosion / Bank Caving			39.166313 °	39.166313 °
				-121.937546 °	-121.937546 °
DWR ID	DWR_NA0016_01_s_2019_119				
Comment Code					
E1 : Note and monitor erosion site.					
Inspector Comment					
There appears to be a new erosion on the waterside berm. Recommend monitoring.

View of erosion from the crown. Spring 2019.

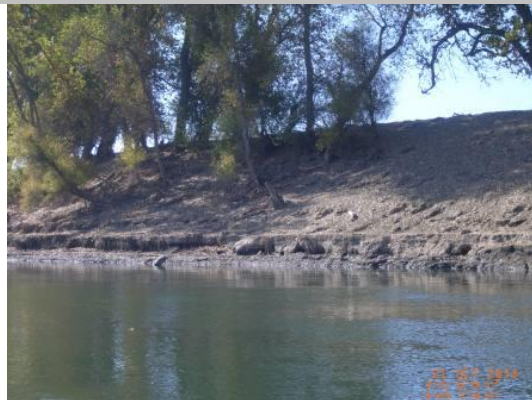
Photo 1 of 1 : FA_2019_NA0016_435_95_20190829_00033.jpg

LM Start	42.90	Rating **	A/W	Issue No.	95
LM End	43.09	Issue Type +	Ma	Location *	WS
Category	Supplemental			GPS Latitude/Longitude	
				Start	End
Item	2017 USACE Erosion Survey			39.172501 °	39.174949 °
				-121.939053 °	-121.940737 °
DWR ID	DWR_NA0016_01_f_2018_95				
Comment Code					
Inspector Comment					
2017 Site ID: SAC 136.6 R					
Status: Eroding					
2017 Field Notes: New erosion observed along the entire bank slope.					
Site History: 2010 - Lower portion of 136.7 that did not extend far enough. Abrupt transition from upstream site. 2012 - Site extended upstream, minor new erosion. 2013 - Minor new erosion at the toe.					
New tree popout. Downstream limit extended. 2016 - Site continues to worsen, fresh erosion at toe.

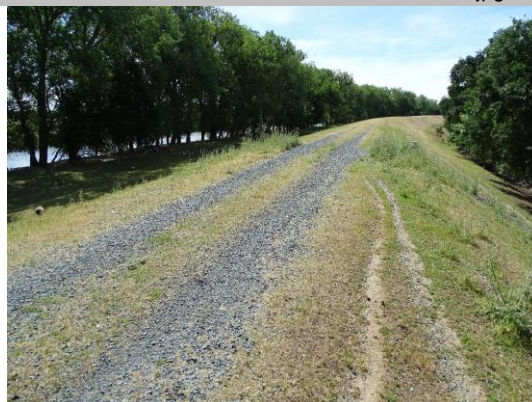
Photo 1 of 3 : UCIP_FA_2019_54219_79919.jpg

Comment Code					
Inspector Comment					
DS_ID:25485 FS_ID:54219 EP_NO: N/A Repair Type: Non-Urgent Crossing Status: Found UCIP Comments: 05/23/2019 Unauthorized encroachment. (O.Yakimov - DWR UCIP)05/23/2018 Contacted NA0016 superintendent about history and current status of the crossing. Confirmed that LMA has no additional information about this crossing that was put in before spring of 2017 (DWR UCIP-O.Yakimov) FIELD_STRUCT_DESC: 4-inch polyvinyl chloride (PVC) irrigation pipe through the levee, of an unknown depth below crown. Siphon breaker off landside (LS) shoulder. The pipe irrigates landscape on the waterside of the levee and is not permitted. Pipe found by DWR inspector Zach Jojola during Spring 2017 inspection. FS Date: 5/23/2019 4:05:59 PM

Levee crown at crossing

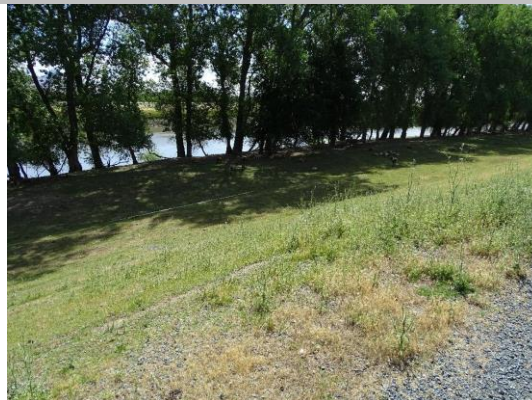
Photo 2 of 3 : UCIP_FA_2019_54219_79920.jpg

WS slope at crossing

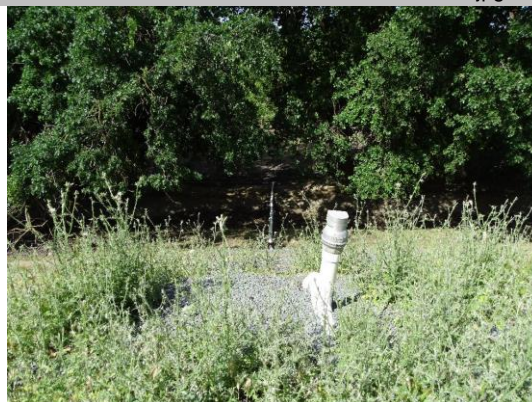
Photo 3 of 3 : UCIP_FA_2019_54219_79921.jpg

Air vent on unauthorized PVC pipe through the levee

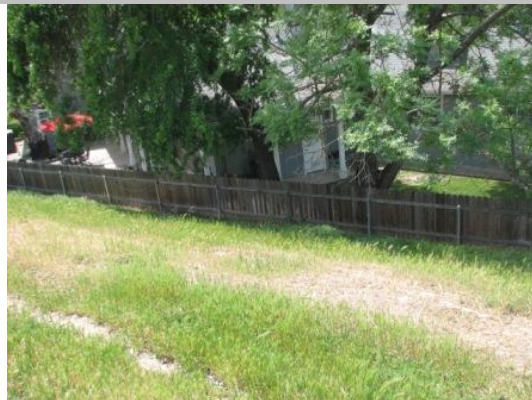
Photo 1 of 1 : FA_2019_NA0016_435_46_20190829_00016.jpg

LM Start	43.24	Rating **	U	Issue No.	46
LM End	43.24	Issue Type +	En	Location *	LS
Category	Earthen Levee			GPS Latitude/Longitude	
				Start	End
Item	Encroachments			39.176429 °	39.176429 °
				-121.942889 °	-121.942889 °
DWR ID	DWR_NA0016_01_s_2012_46				
Comment Code					
FE : Fence					
Inspector Comment

A solid fence along the toe of the levee. Photo taken spring 2012.

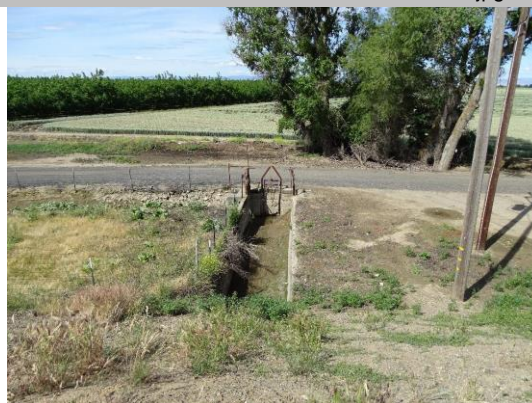
Photo 1 of 3 : UCIP_FA_2019_54221_79924.jpg

LS slope and concrete structure at LS toe

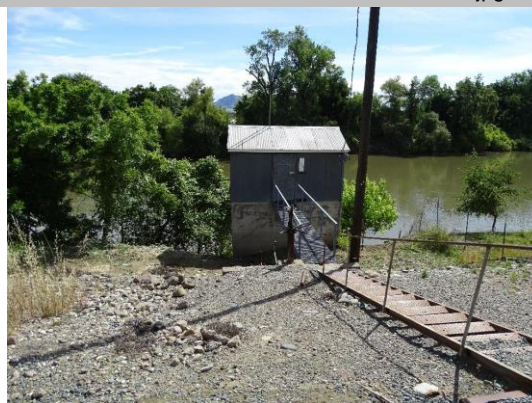
Photo 2 of 3 : UCIP_FA_2019_54221_79925.jpg

WS slope, steps, and pumphouse on WS

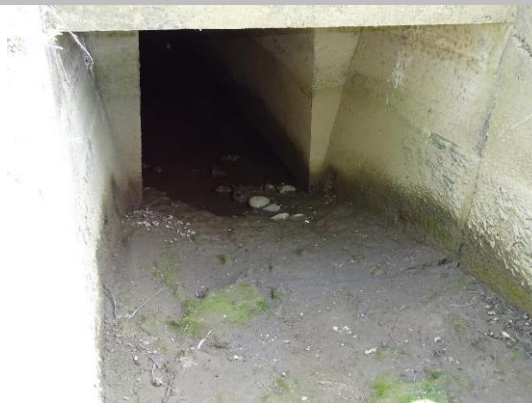
Photo 3 of 3 : UCIP_FA_2019_54221_79926.jpg

4' x 5' concrete culvert at LS toe

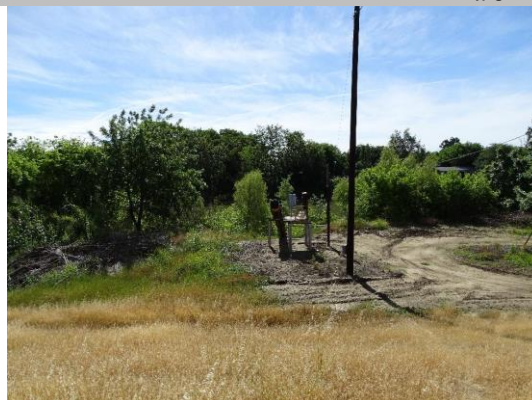
Photo 1 of 3 : UCIP_FA_2019_54223_79931.jpg

Comment Code					
Inspector Comment					
DS_ID:20293 FS_ID:54223 EP_NO: 5307 Repair Type: Non-Urgent Crossing Status: Found UCIP Comments: Uncovered CMP riser is too low. Potential fall hazard. Gap between concrete box and LS toe was filled with concrete. (O.Yakimov - DWR UCIP) FIELD_STRUCT_DESC: 2 of 2: 24-inch steel irrigation pipe through the levee, 5.3 feet below the crown. Metal cutoff wall. Slant pump on the waterside (WS) bank. Siphon breaker inside a 31-inch corrugated metal riser unit on the landside (LS) shoulder. Discharges into a concrete box at the LS toe. (Permit No. 5307, 1966 - George Steidlmayer). [Additional Reference(s): DWR Levee Log, 2006]. FS Date: 5/23/2019 1:18:17 PM

Pumping platform on WS berm looking from levee crown
